CM42-EZ Clamping System Issue

Tech Brief - October 29, 2015

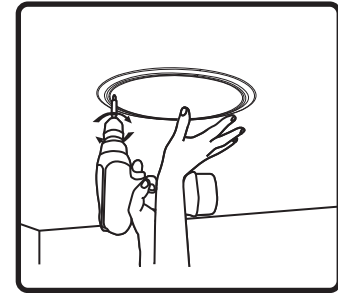
There is a possible problem with the clamping system on this speaker which MAY cause the clamping mechanism to bind when tightening the clamping wing screws. In order to avoid this problem please take the following steps.

1. When initially tightening the clamping wing screw, go SLOWLY for the first few revolutions. If the system is going to bind up it will happen early in the process of tightening the wings.
2. If the screw does bind up, stop and rotate the clamping screw backwards (counterclockwise) just enough to take the pressure off the screw – ¼ turn is sufficient. You may hear a slight click when the screw is backed off. This is the clamping wing releasing and is OK.
3. Proceed to SLOWLY rotate the clamping screw clockwise (tighten). If the system binds up again, repeat the process (backing off the screw ¼ turn and then slowly tightening) until the clamping screw will turn freely.

4. It should not be necessary to repeat this process more than two, possibly three, times per mounting screw before the screw turns freely.
